FINAL REPORT

Primary Project Title: Silver Creek Sediment & Nutrient Reduction & Habitat Restoration

**Managed Grazing - Paired Field Monitoring: Evaluation of the Water
Quality Impacts of Managed Grazing with a Paired Study Design in
N.E. Wisconsin.**

October 2021

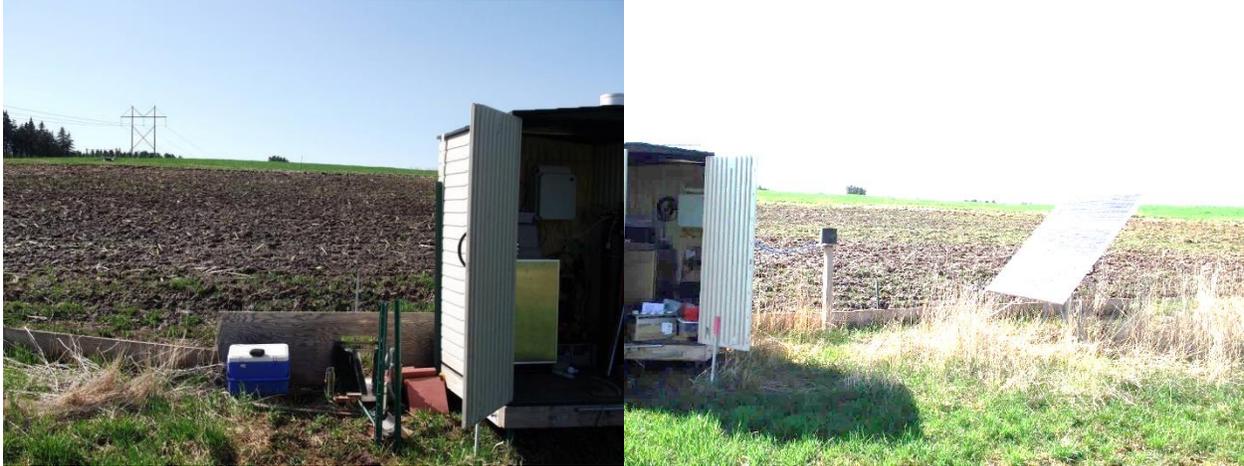
Figure 4. Station housing and monitoring equipment at outlet of south catchment (left, 5/5/18) and north catchment (right). Turbidity probe is mounted below flume in half-pipe.

Surface water run-off was directed toward an H-flume by installing small dirt berms and treated plywood wing-walls to direct runoff from the catchment to a single inlet where a 1.0 foot H-Flume served as the control structure. A two foot high 2x3 inch welded wire mesh fence was installed just upslope of the flume to ensure that trash/debris from the field did not enter and clog the narrow outlet of the flume (Figure 5). A nitrogen tank and Conoflow sight feed regulator assembly provided a steady supply of gas to a bubbler orifice line that was inserted near the H-flume stage height location and affixed at the bottom of the flume. A Sutron Accubar pressure transducer system measured how much pressure was in the line due to water depth, which was converted to feet and recorded by the datalogger. The higher the stage in the flume, the greater the pressure in the line. A 16 minute data recording interval was used during non-event conditions and 2 to 8 minute intervals during storm events, depending on event duration.

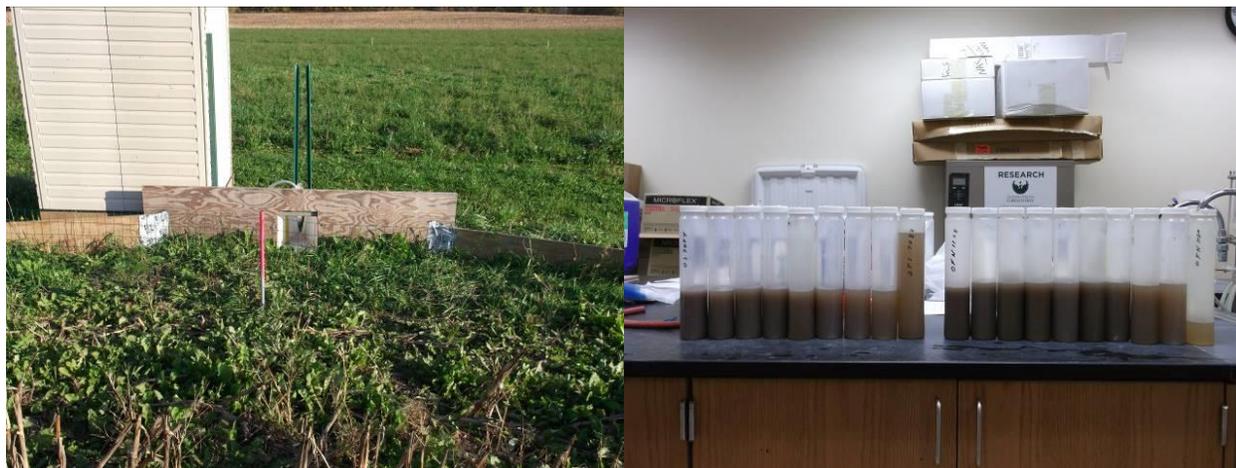
Figure 5. Photo view looking downslope toward north station plywood berms and 1' H-flume, with trash fence just upslope of flume to prevent clogging of narrow flume outlet by debris (left, 10/22/16). Image on right of south and north station automated sampler bottles collected from 4/20/17 event and awaiting compositing and processing.

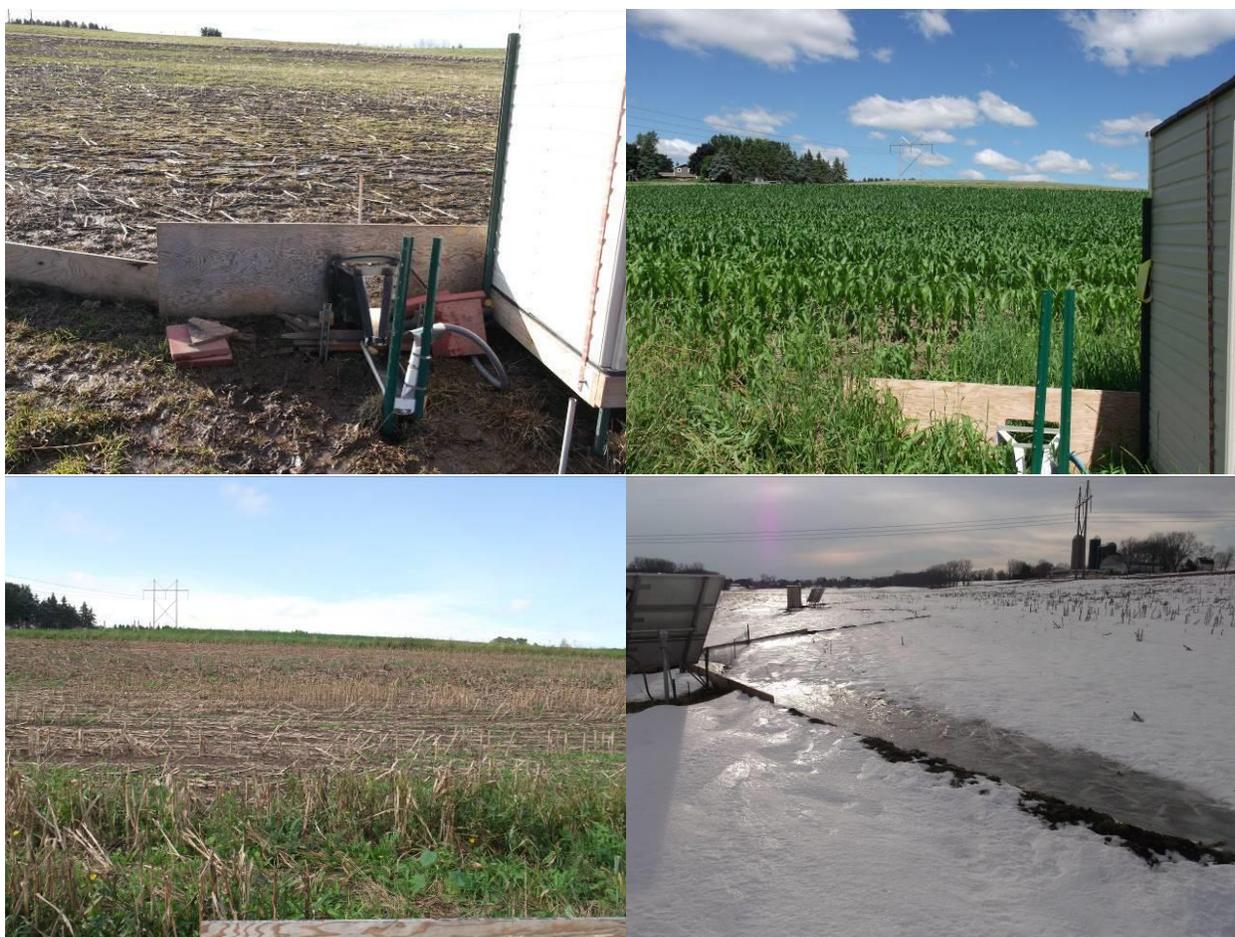
Figure 6. Seasonal images at study site: wet conditions during sample collection on 4/4/18 (upper left), corn crop well underway by 6/28/16 (upper right), after corn silage harvest (lower left, 9/21/16), and during 12/28/16 winter melt conditions (lower right). The winter site visit conditions confirmed our expectations that snow melt sampling would not be likely given the large volume of frozen runoff water that was held up by the berms and flume setup.

Crops, Tillage and Nutrients: Both field catchments were managed the same by the initial farm operator through the first part of the study. Crop practices in these catchments consisted of corn silage in 2015, 2016, 2017 and 2018. Commercial fertilizer and manure were applied to the study site. Fertilizer was incorporated at planting. Manure was incorporated with fall tillage or injection after harvest. Typical tillage included fall chisel plow after harvest and a field cultivator prior to spring planting. A transition to a new farm operator, the Oneida Nation which owns the land, and record-setting rainfall in 2019 prevented planting a corn crop in 2019. This problem is discussed in detail later in this section. Typical pre-treatment seasonal site conditions can be seen in Figure 6 and Figure 9 (left).

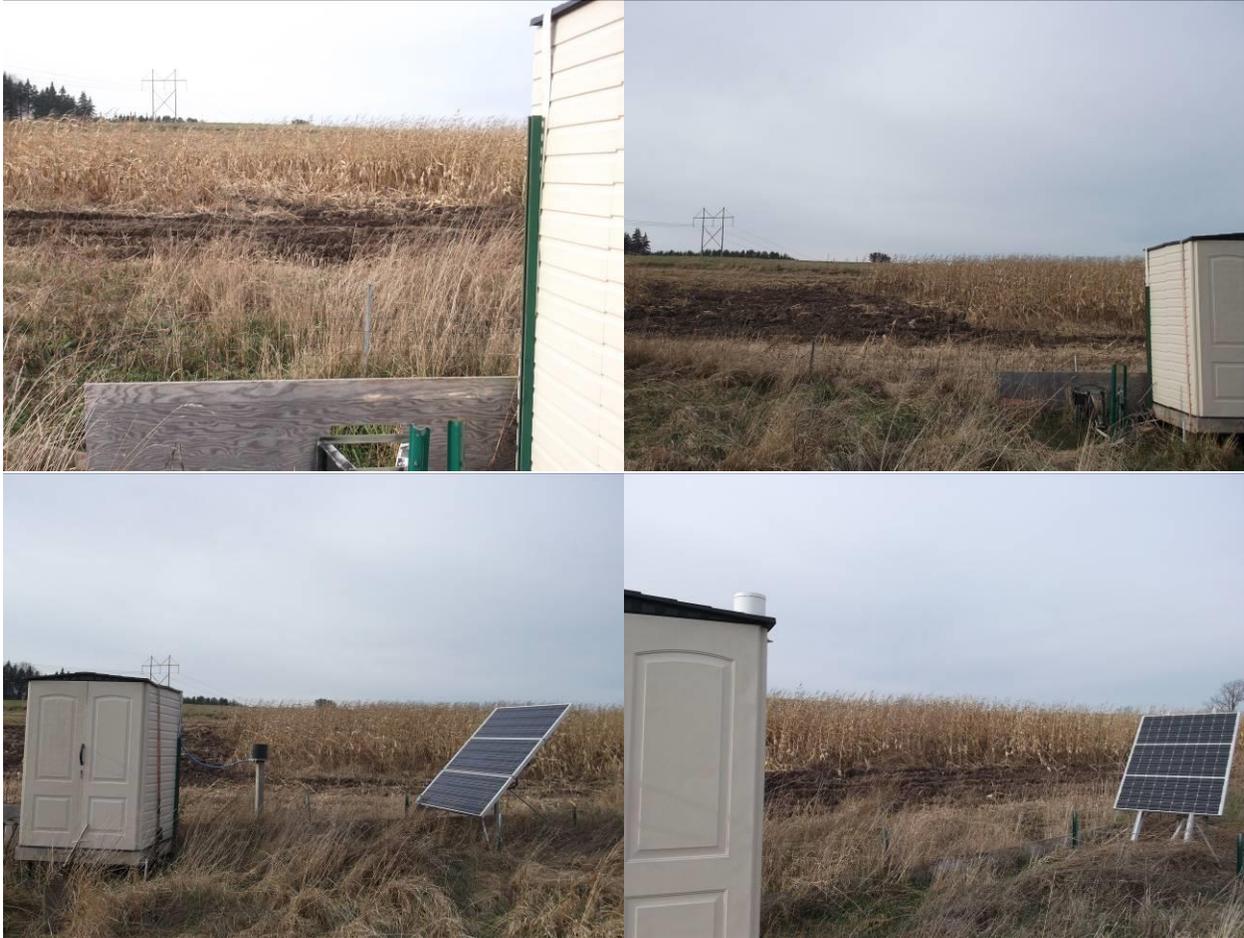
Figure 7. Photos of field ruts caused by harvesting under wet conditions, and standing corn crop yet to be harvested as of 11/23/18 (date of photos). The deep ruts greatly disrupted runoff flow paths and created settling areas for TSS and phosphorus, so representative water samples could no longer be counted on. It seemed unscientific to eyeball the samples collected during each ensuing runoff event to see if they looked representative or not (i.e., to toss or keep). Heavy rains in 2019 and some grazing of cattle did little to level the ruts. Therefore, water monitoring was discontinued until tillage removed the ruts in May 2020.

Unfortunately, a number of factors disrupted our planned schedule: (a) the farm operator had a major spillage issue with their manure storage system in summer 2018 which diverted focus from our collaborative study; (b) unusually high rainfall from August 28, 2018 through October 2018 created wet field conditions; (c) farm operator substantially delayed harvesting corn silage crop until very late October or early November 2018, by which time crop moisture was actually too dry for a good silage crop; (d) corn crop was finally harvested as silage prior to a November 5, 2018 runoff event, but it was too late and wet to plant the grazing mixture; (e) field was deeply rutted by the harvesting equipment during initial harvest, and some standing crop was left unharvested because that portion of the remaining field was too wet (Figure 7); (f) operator finished harvesting the remaining silage crop, but left even more and deeper ruts (Figure 8), so potential samples from a runoff event in December were not collected since it was unreasonable to expect that the samples from both plots would be representative, or could be expected to still have a good relationship between them. Many of the ruts left by the harvesting equipment in fall 2018 were over 12 inches deep, as seen in Figures 7 and 8.

Therefore, the planned no-till pasture mix seeding could not take place in fall 2018. Importantly, the deep ruts held-back and/or diverted runoff from the field in an unpredictable fashion. The ruts seemed worse in the north catchment, so the impact of the ruts was not likely to be the same in both catchments. Furthermore, the slopes of the study plots are nearly planar in nature, so they don't strongly focus runoff along a concentrated pathway; thereby, exaggerating the impact of the ruts on runoff variability during runoff events (variability in direction of runoff, and volume). So, runoff could go between the plots, or outside the plot areas depending on variables like wind direction/speed or any slight alteration due to corn stalks, etc. In addition, the ruts served as runoff detention areas and likely would have served as areas where suspended soil particles settled during runoff events, greatly disrupting the viability of representative runoff samples. Unfortunately, the ruts remained in the field from fall 2018 until the north control catchment and a small portion of the south treatment catchment were rotary tilled in May 2020. Only then could paired water sampling resume.

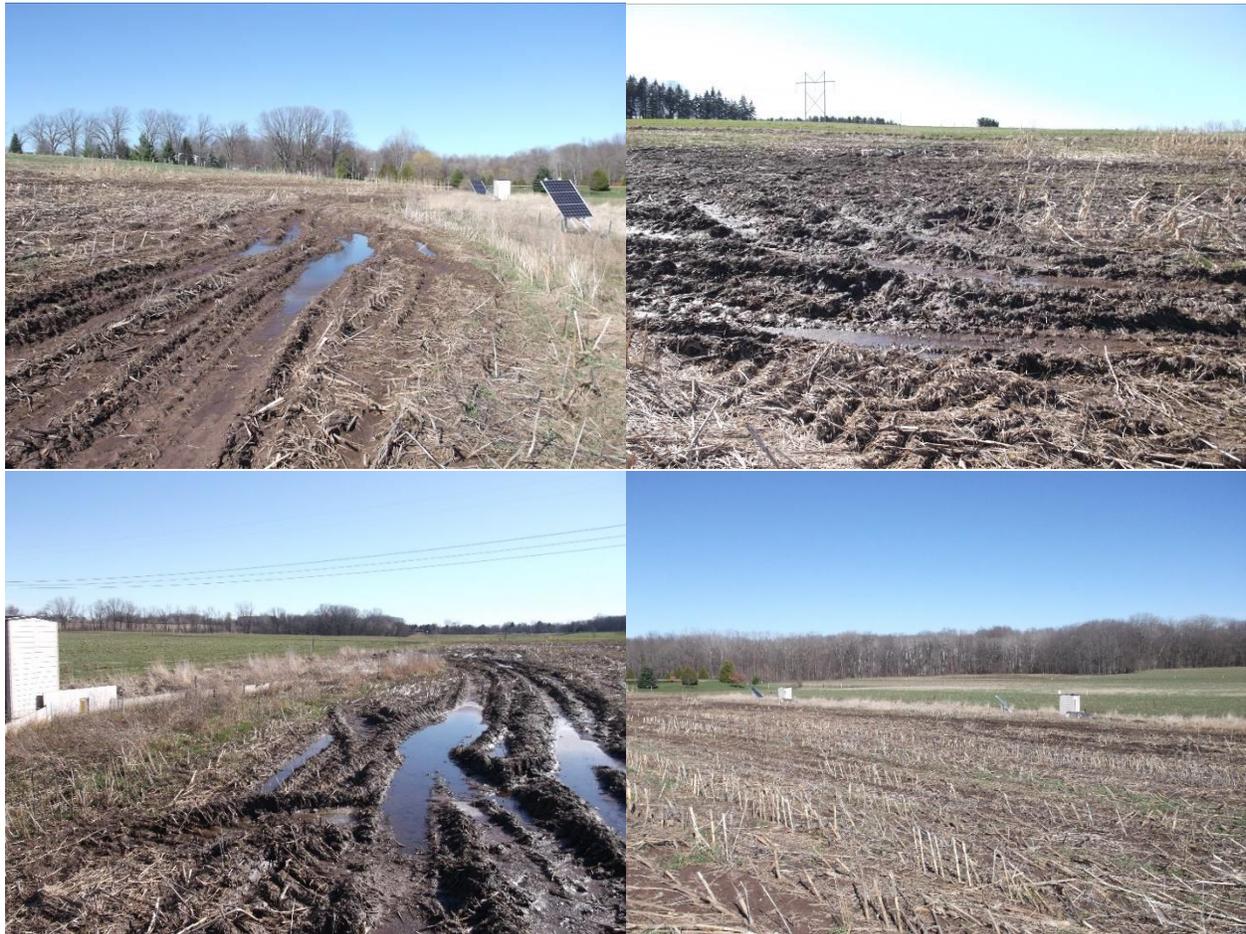
Figure 8. Photos taken 4/19/19 of deep ruts looking toward north catchment (upper left), upslope of north catchment (upper right), just upslope of south catchment outlet (lower left), and looking downslope toward both monitoring stations (lower right). These ruts greatly disrupted the flow path of runoff until spring tillage in 2020.

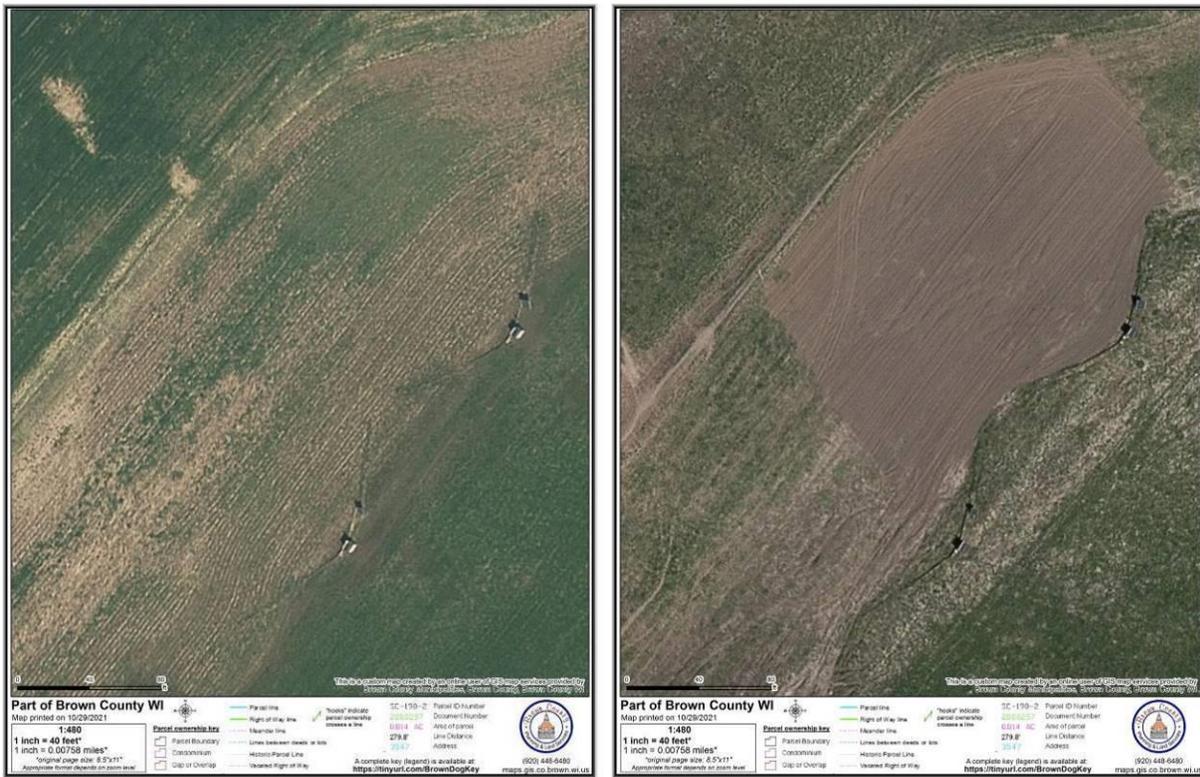
Figure 9. Aerial orthophotos of grazing study monitoring stations and catchments: April 2017 (left) during pre-treatment phase, prior to spring tillage and planting, and May 2020 (right) at beginning of treatment phase, after spring tillage and corn planting in north control plot. Additional grazing pasture mix was planted in the south treatment plot shortly after May 2020 to fill in the areas that were tilled to remove deep ruts from 2018 late corn silage harvest. Note grazing area surrounding north control plot, including most of the south treatment plot in the May 2020 image. Monitoring station houses, solar arrays, wood wingwalls and runoff collecting berms can be seen in these images.

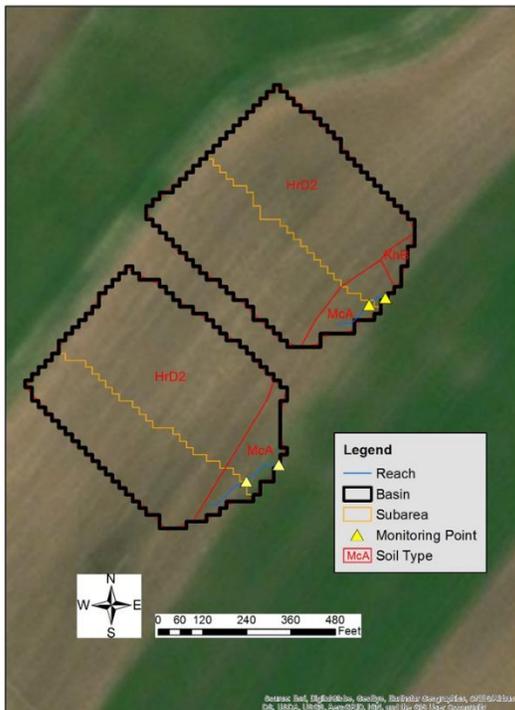
Figure 16. Watershed boundaries, subareas, water reaches, soils, and outlet points for Oneida North and South paired watersheds as modeled by Kalk (2018). Soil type map units are from the USDA SSURGO database.

UWGB APEX Field Modeling Project: In his graduate thesis for the University of Wisconsin-Green Bay, Kalk (2018) conducted an evaluation of the Agricultural Policy/Environmental eXtender (APEX) model (Steglich et al. 2019) to simulate runoff, sediment, and phosphorus loss from agricultural fields in northeast Wisconsin, which included delineating and modeling the two catchments in this grazing study (Figure 16). As an extension of the project work, initial modeling using data from the paired grazing study EOF catchments was performed by Kalk. The same USDA APEX model framework and parameter set used to calibrate other EOF sites in the Lower Fox River watershed was used to simulate runoff, TSS and phosphorus losses from the north and south catchments. These sites had the smallest observed runoff per unit area of all sites tested in Kalk’s study. An example of his work to simulate event runoff at the two project sites is shown in Figure 16, where the general response to the events was good.
