Lower Green Bay and Fox River Area of Concern (AOC)

Fish and Wildlife Habitat Assessment

Wildlife Habitat and Water Quality Opportunities

Prepared by The Nature Conservancy

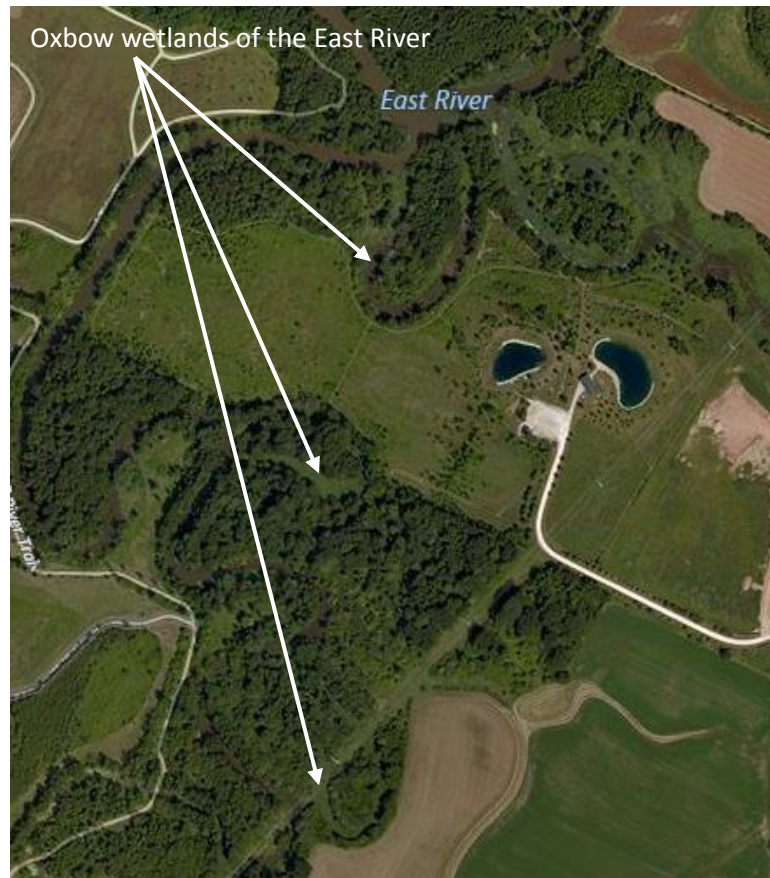
Figure 5. Oxbow wetlands of the East River, Village of Bellevue

This section of the East river flows through the “Preble Plains” land type association within the Central Lake Michigan Coastal Ecological Landscape of Wisconsin. The characteristic landform of the river corridor is a nearly level alluvial lake plain of offshore stratified sediments of the Nipissing Lake plain. These sediments have been determined to be several up to 10 meters thick (Need, 1983). Soils of this association are predominantly well drained silt loams, e.g., Oshkosh, Bellevue, Manawa and Poyan silty clay loams, over the calcareous clay lacustrine sediment or till. Near the upper end of the assessment area units of sandy loam soils are found intermixed with the silt loams. The water level of the main stem of the river drops about 3 feet through this stretch, and the river has a sinuous and meandering character with oxbow wetlands present in the floodplain of the river, especially at its confluence with Bower Creek. The most significant oxbows are present in the villages of Allouez and Bellevue above County Road XX (Hoffman Road) (44.456633 / -88.017536). (Figure 5).

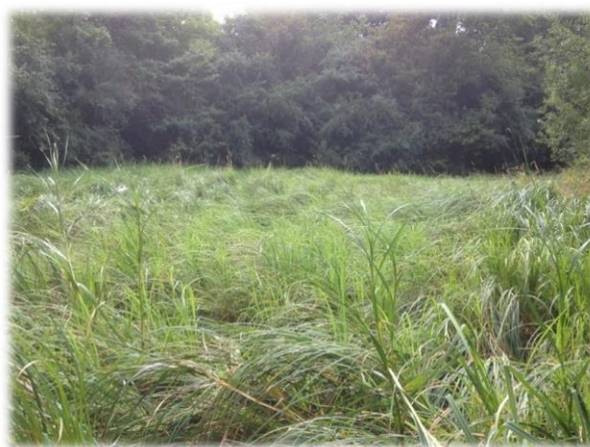
Figure 6. Sedge meadow of an oxbow wetland near the confluence of Bower Creek and the East River

- Several intact oxbow wetlands each with unique hydrology but in general holding patches of fair to superior quality sedge meadows (Figure 6);

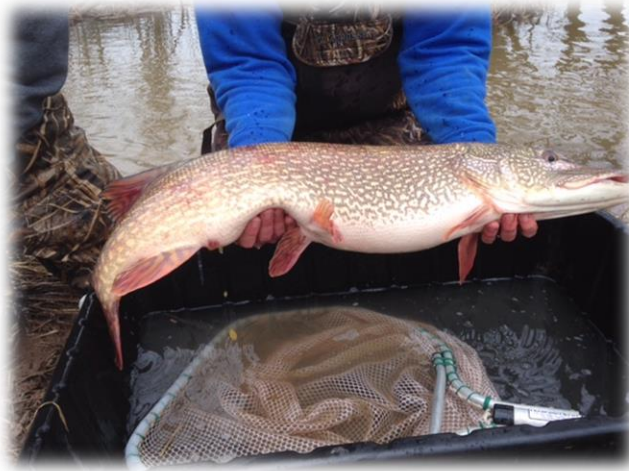
Figure 7. Female northern pike captured during the spawning run on a small tributary to Bower Creek.

- Large river fringing wetlands with varying, but mostly good, connectivity to the open water of the river and holding examples of both inland emergent marshes and sedge meadows, though in most cases the wetter areas have become dominated by non-native *Phragmites* and the sedge meadows in several settings have been invaded by reed canary grass;
- Unimpeded open water access for Green Bay migratory fish to wetlands fringing the main stem of the river and several small tributaries of the river (Figure 7);

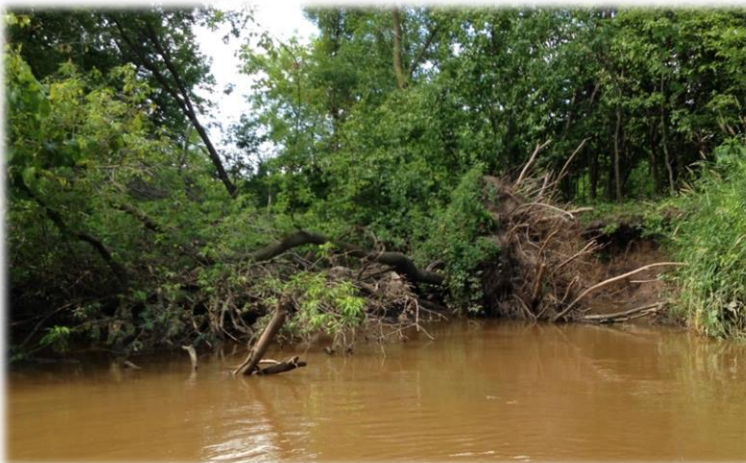
Figure 8. Large green ash (*Fraxinus pennsylvanica*) which was undercut by the stream and toppled into the East River during the assessment. The tree completely crosses the stream. Note height of scoured bank below tree roots.

- Significant amounts of coarse woody debris exist throughout this stretch of the river and increasing amounts can be expected as the riparian trees on the scoured outer cutbanks of the meanders mature and eventually fall into the river. (See Figure 8). The upper reaches of the assessment area have the largest amount of this structural feature;

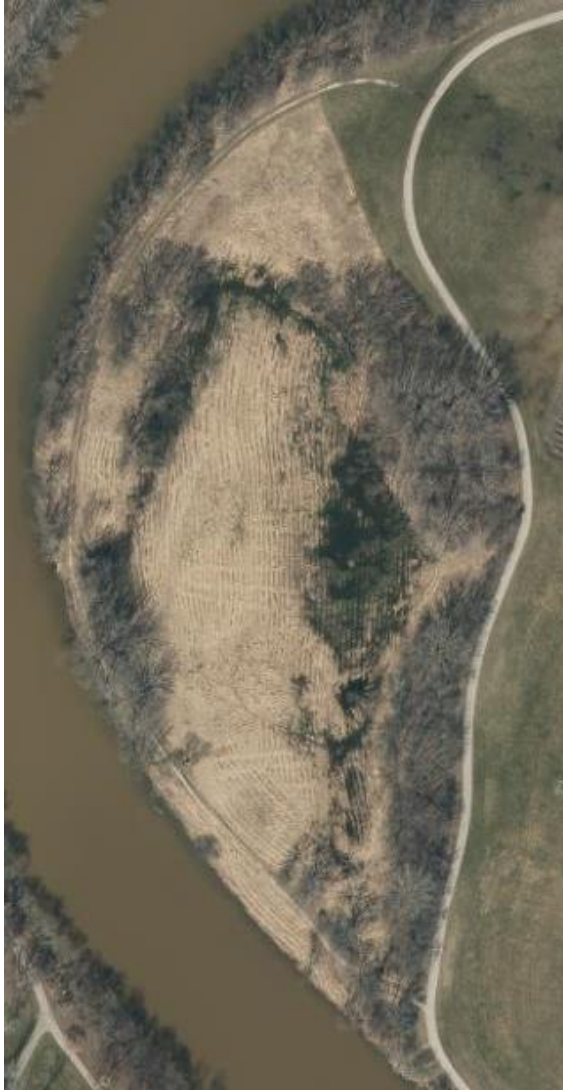
Site 1: Van Beaver Park Wetland 1

This site is located wholly within Van Beaver Park, city of Green Bay, and .24 miles upstream of the East Mason Street Bridge on the east side of the river; (center of site: Lat: 44.4962, Long: -87.9976). The open water of the Fox River is 2.5 river miles from the wetland and the site is 1.2 miles from the open water of the Fox River by air.

Non-native vegetation dominates the upland and wetland soils of the site. Phragmites and reed canary grass dominate the core of the emergent wetland, though the condition of the Phragmites has been severely degraded by a fall 2016 herbicide treatment.

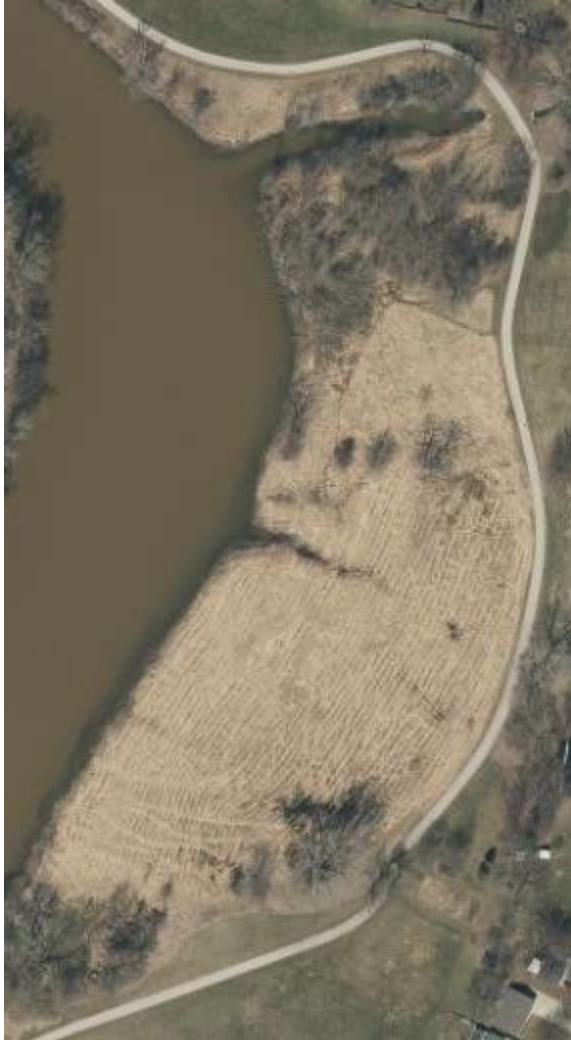
Site 2: China Plate Wetland

This site is also located just south of Van Beaver Park, city of Green Bay, approximately .25 miles upstream of site #1 on the east side of the river; (center of site: Lat: 44.4919, Long: -87.9941). The open water of the Fox River is 2.75 river miles from this site and the site is 1.4 miles from the open water of the Fox River by air.

This site is a longitudinally isolated riparian wetland comprised almost entirely of an emergent marsh recently dominated by Phragmites and reed canary grass. The site is laterally connected to the main stem of the East River along its entire length (about 1.7 miles) and no rip-rap fill was noted at the site. An urban storm water drain enters the site from the northeast through a shrub thicket lined channel, and a minor intermittent flow path drains the middle portion of the wetland. Historic photos indicate the site was used in times of low water for agriculture (hay meadow) but no evidence of fill was noted.

Phragmites and reed canary grass dominate the core of the emergent wetland, though, as in Site #1, the condition of the Phragmites has been severely degraded by a fall 2016 herbicide treatment.

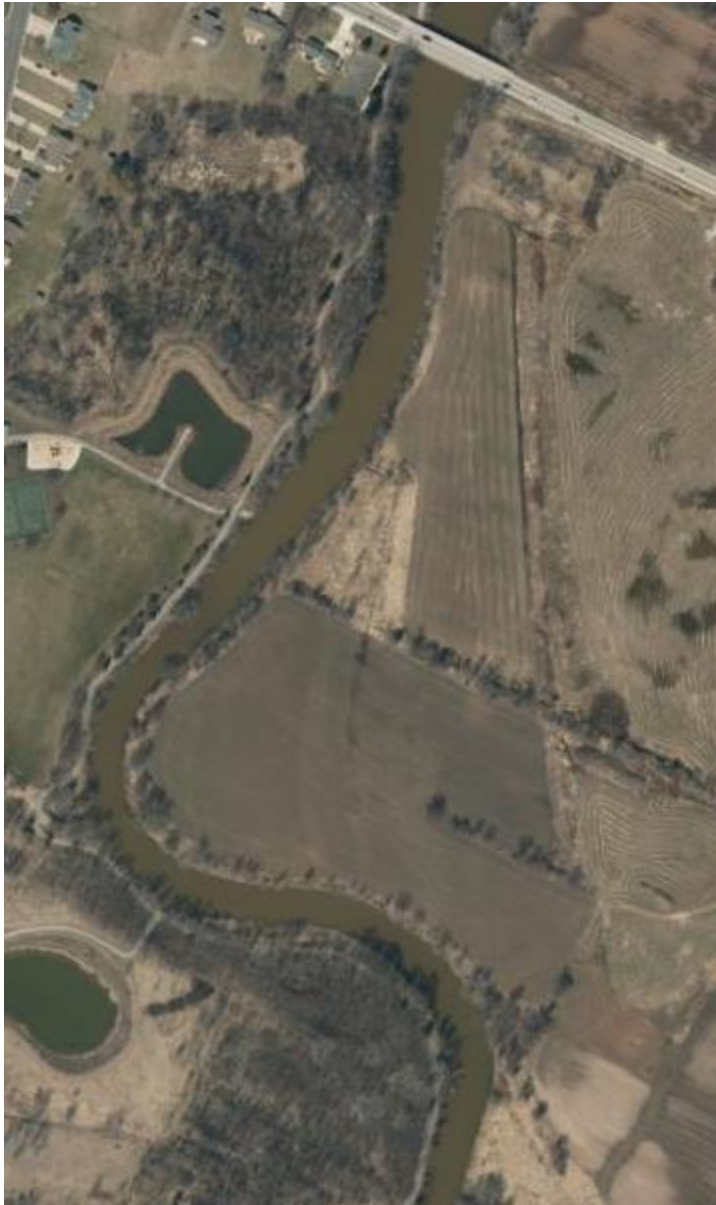
Site 7: East Hoffman Road Site

This site lies just upstream from East Hoffman Road with its center at approximately Lat. 44.4534 and Long. - 880193. The site center is about 6.76 miles from the confluence of the East and Fox Rivers by river miles and 1.8 miles by air east of the Fox River. The Village of Allouez owns the land on the west side of the river and several private lands were included in the site on the east side of the river.

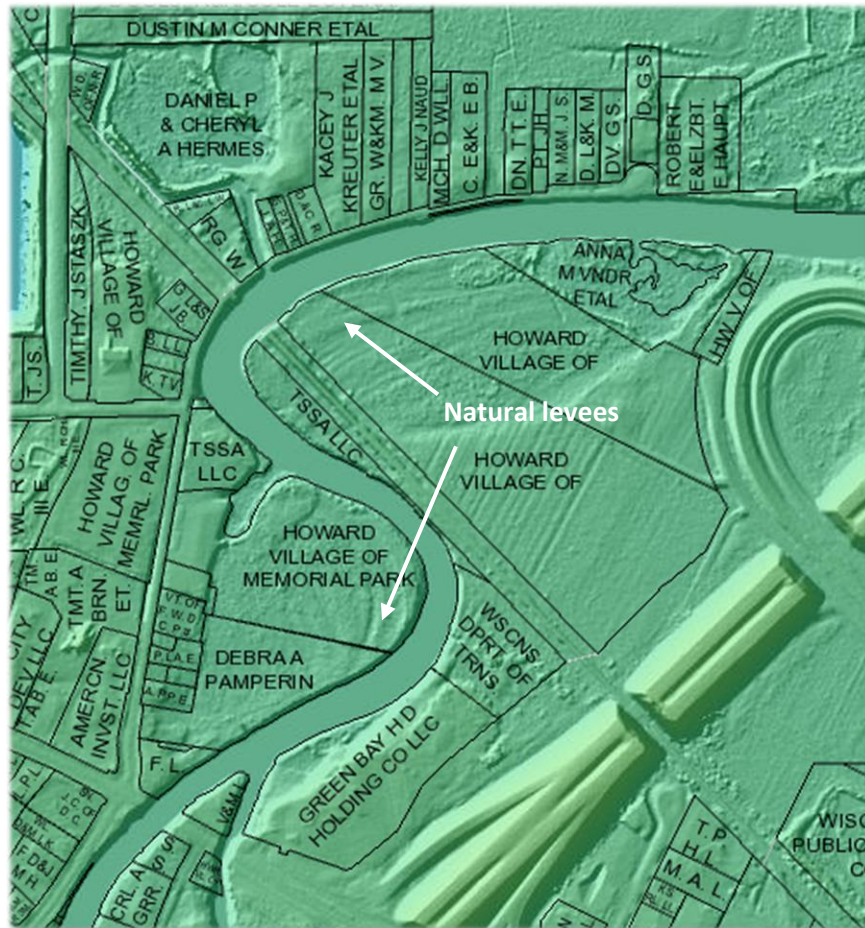
Figure 9. Landform image of lower Duck Creek showing a sequence of natural levees laid down as Duck Creek has migrated across its floodplain.

The assessed section of Duck Creek flows through the "Howard Ridges" and "Green Bay Plain" land type associations within the Central Lake Michigan Coastal Ecological Landscape of Wisconsin. The Howard Ridge association covers the upper portion of the area grading into the Green Bay Plain association near the Highway 41/141 bridge. The Howard Ridge association, as expressed in the Duck Creek riparian corridor, comprises a mix of rolling ridge and plain landforms of predominantly well drained silty clay or sandy loams (e.g., Yahara, Manawa, Sisson and Shawano soils) and wet to dry alluvial soils in the floodplain along the stream. The Green Bay Plains association near the mouth of the creek lies in the nearly level silty sediment of the Nipissing Lake plain with scattered low dunes and a series of low natural levees on the point bars where the stream has migrated laterally across its floodplain (see Figure 9). Soils are predominantly mucks, alluvial wet soils and nearly level loamy fine sands. Common habitat types include lowland hardwood stands, shrub carr, sedge meadow and emergent marsh vegetation in the wettest swales or near the stream.

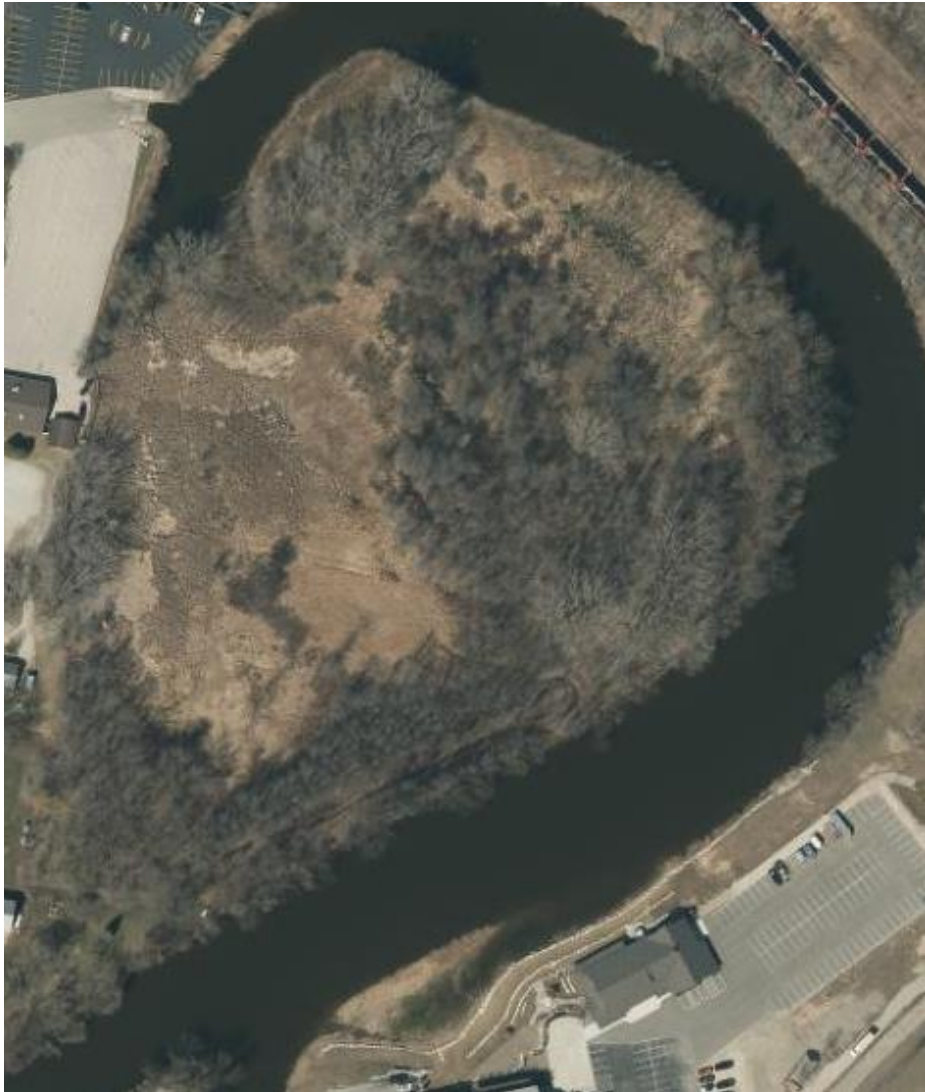
Duck Creek Site 9: River's Bend Sedge Meadow

This site is located approximately 1.5 upstream from the mouth of Duck Creek just upstream from the River's bend Supper Club on the west side of the stream (Lat. 44.5604; Long. - 88.0612). The site has both public (Village of Howard) and private ownership.

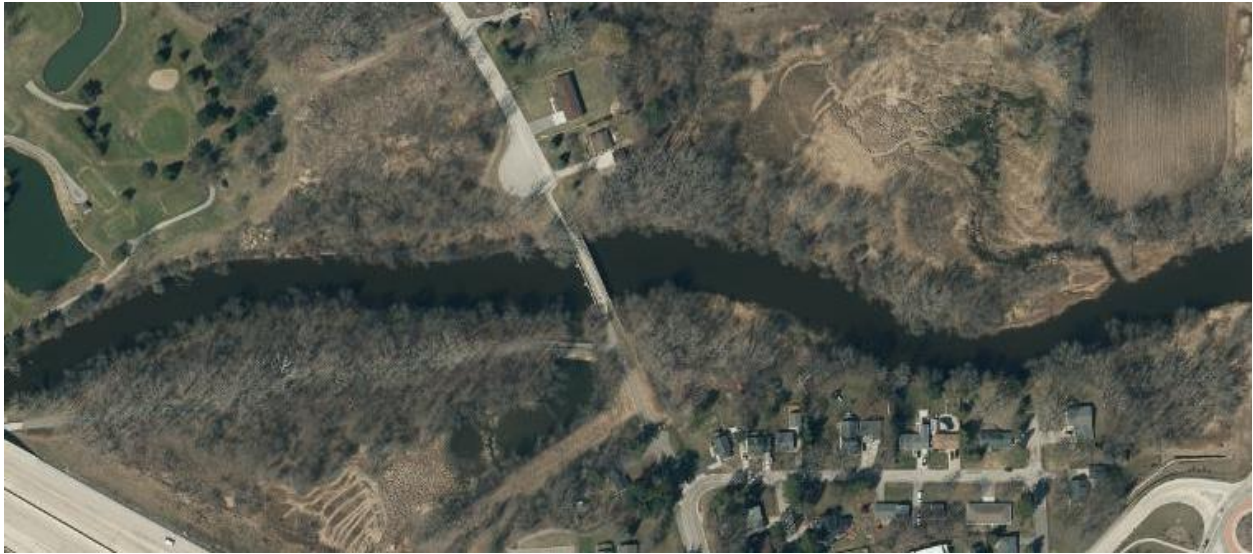
Duck Creek Site 11: Lower Park Corridor

This site lies between the bridges over Highway 29 and Cardinal Lane (County Trunk EB). The center of this site is approximately 44.5464; Long. -88.0903. Land ownership is a mix of public (Brown County Pamperin Park) and several private land owners.

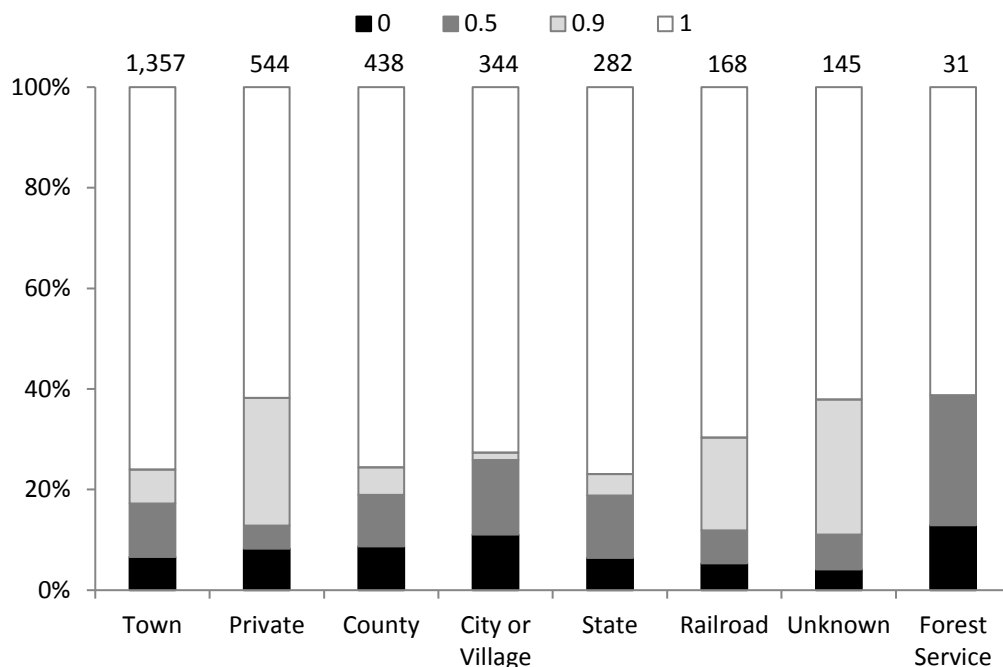
Figure 1. Percent of structures in each passability class by ownership category. Labels above each bar are the number of structures in that category.

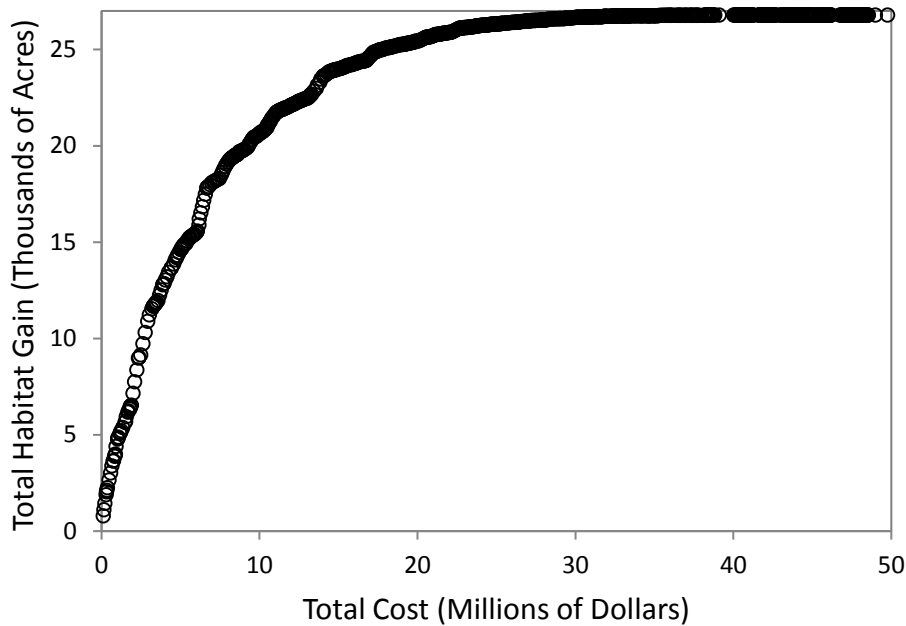
Figure 3. Gain in quality-weighted wetland habitat that would be made accessible as a function of cost to remove barriers.

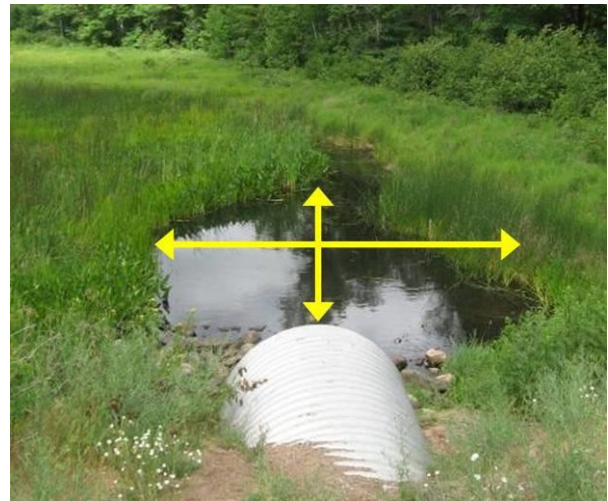
Scour Pool: If the stream channel is noticeably wider and deeper directly below the crossing than in other sections of the stream, this is a scour pool that is created by high velocity water during high flow events.

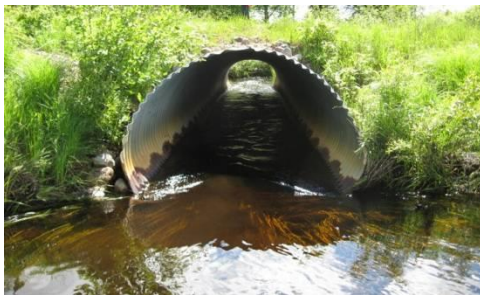
Culvert

Crossing design: Record whether the structure is one or more culverts or a bridge. Both types of structures may be constructed from any material. Culverts have a closed bottom (which may be buried under stream substrate); bridges have an open bottom. For crossings that have more than one culvert, measure the dimensions, substrate, and flow depth and velocity of the culvert that carries the most flow.

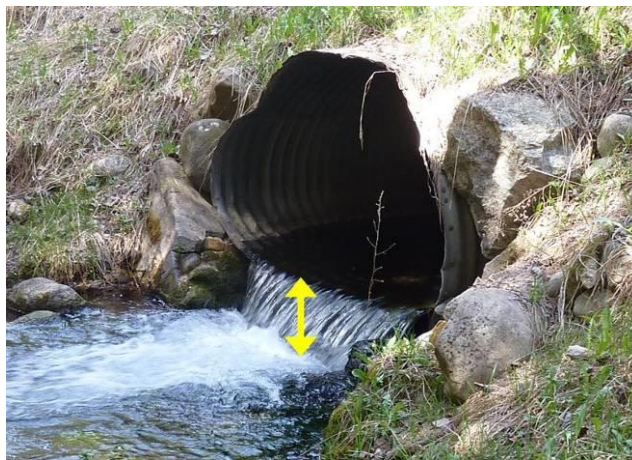
Outlet drop: If the outlet of the structure is elevated above downstream water surface, measure the vertical distance from the downstream water surface to the bottom of the stream crossing structure to the nearest 0.1 foot interval.

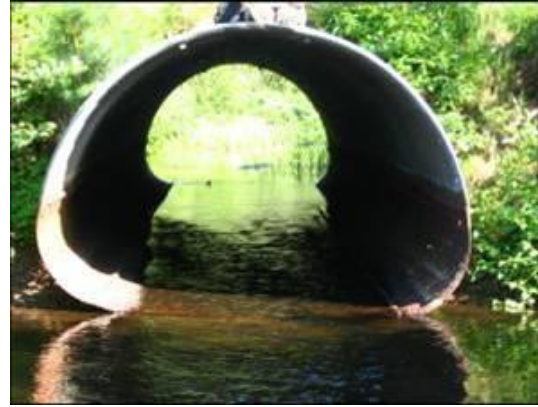
Pipe Arch – similar to a round pipe, but bottom is flattened.

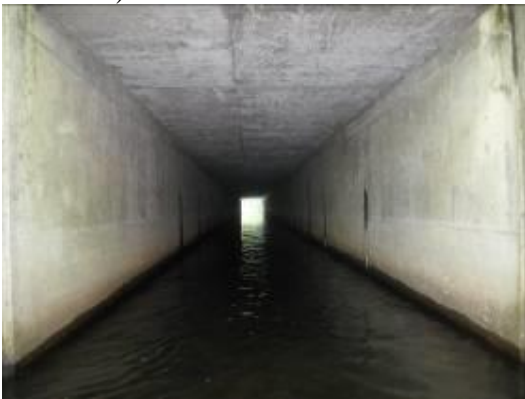
Square/Rectangle – typically concrete, with floor (may be covered with natural stream substrate).

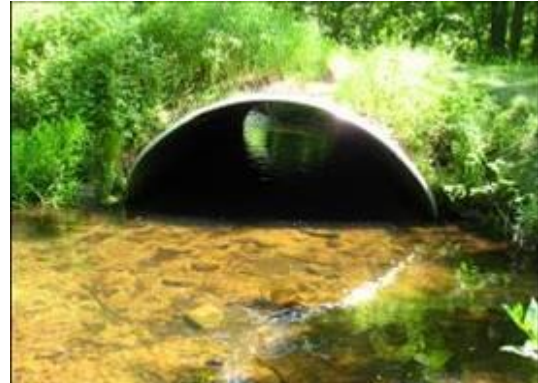
Open Bottom Arch – the walls of the crossing are buried and the stream bottom is undisturbed.

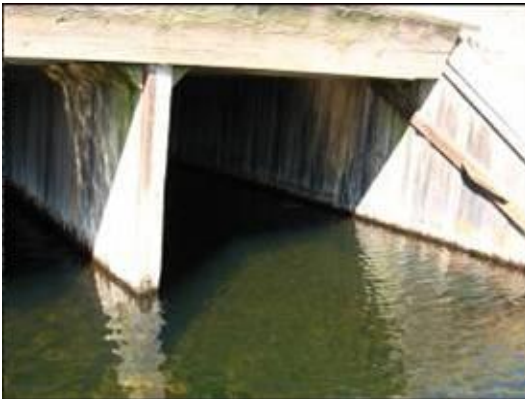
Open Bottom Square/Rectangle – the walls of the crossing are buried and the stream bottom is undisturbed.

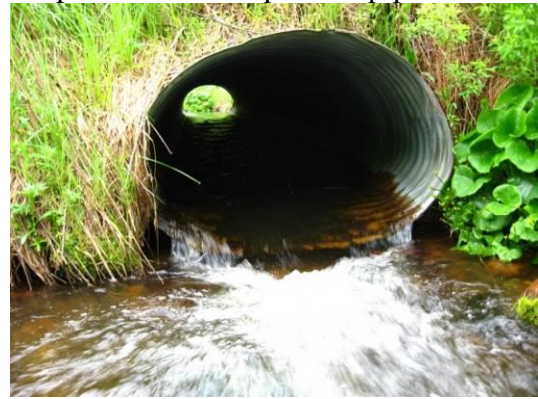
Ellipse – oval or “squashed pipe”.

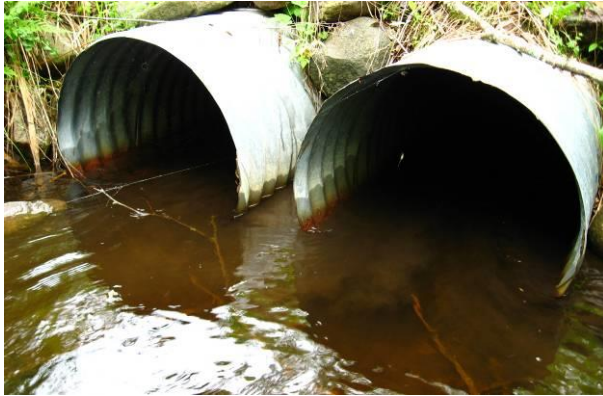
Projecting – end of culvert protrudes from embankment.

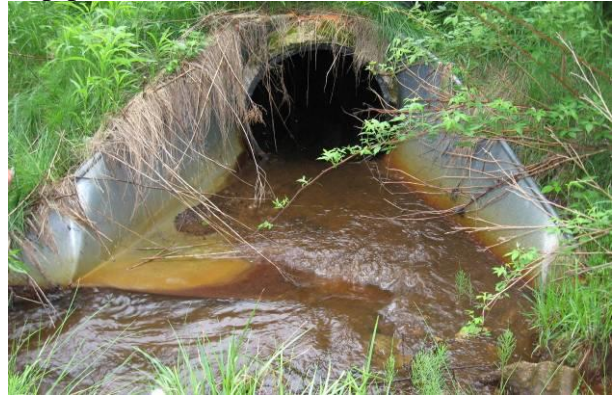
Apron – extension of culvert floor beyond end of pipe.

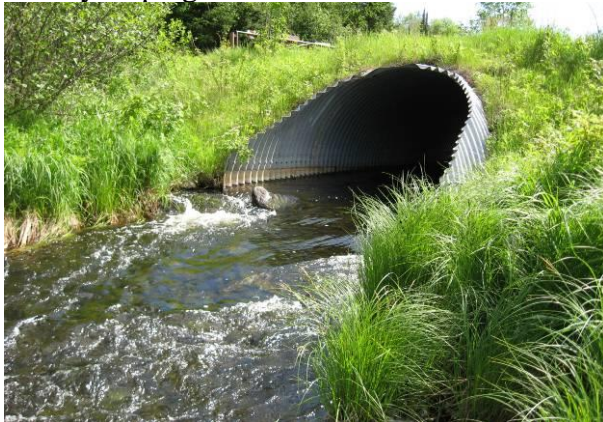
Mitered – end of culvert cut at an angle, usually sloping back toward road

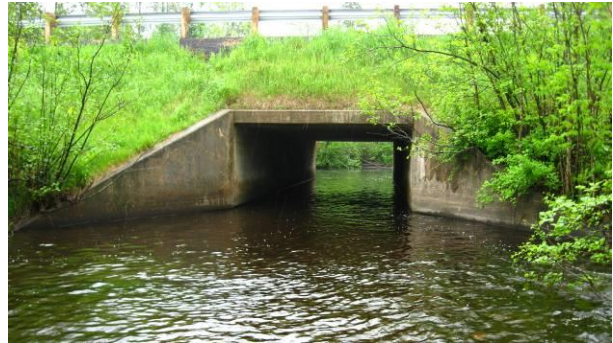
Wingwall – concrete, gabion, masonry, or timber walls that are built out at angles from the inlet.

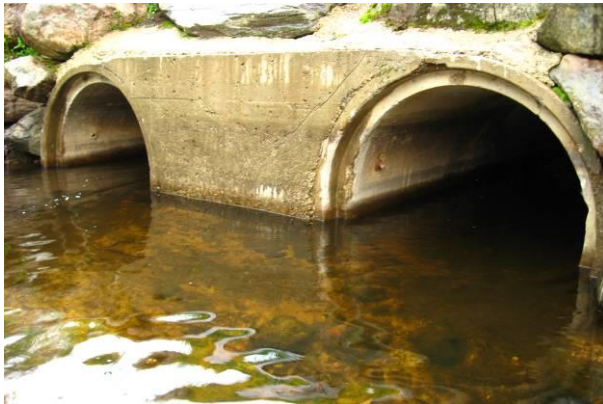
Headwall – concrete, gabion (wire mesh filled with rocks), masonry, or timber wall built around inlet.

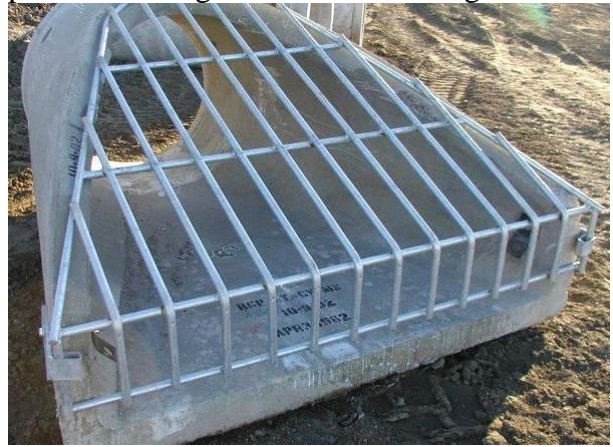
Trash Rack – mesh cover or gate over inlet to prevent floating debris from entering culvert.

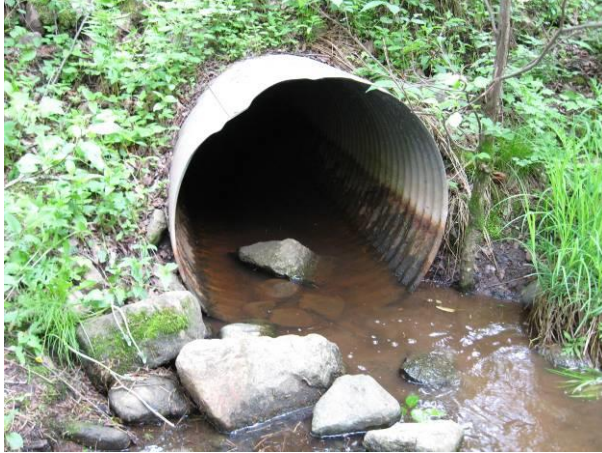
At Grade – bottom of culvert is at the elevation of the stream bed.

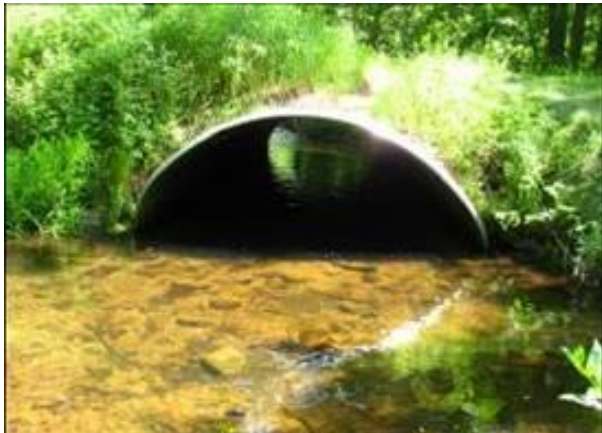
Embedded – the bottom of the culvert is buried below the stream bed.

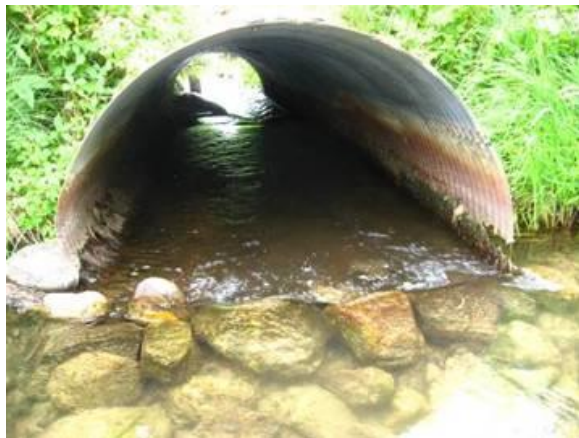
Inlet

Take photos of the inlet, outlet, and views up and downstream. Select the picture you are about to take from the drop down menu on the Picture tab. Then click the camera icon to activate the camera. Push the red button on the right side of the Yuma to take a picture.
